LONG TERM PERFORMANCE AND DURABILITY OF EPS AS A LIGHTWEIGHT FILLING MATERIAL

Tor Erik Frydenlund¹ and Roald Aabøe²

ABSTRACT

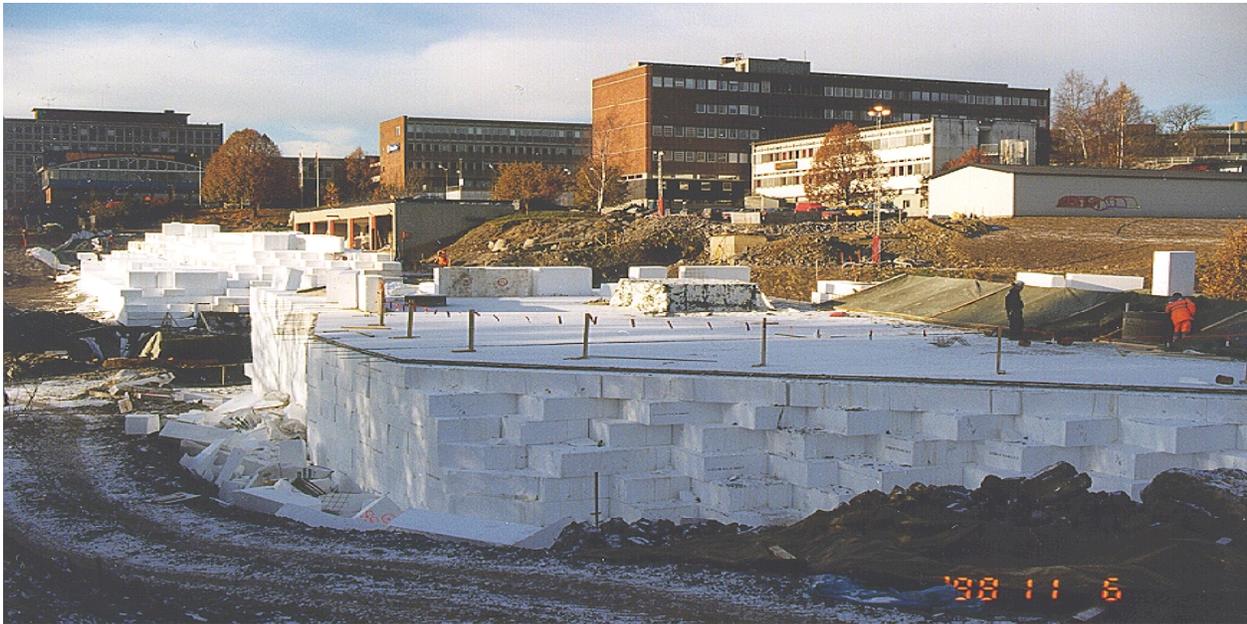
Figure 1. An EPS embankment for a city tramline in Oslo with vertical walls as an alternative to a bridge.

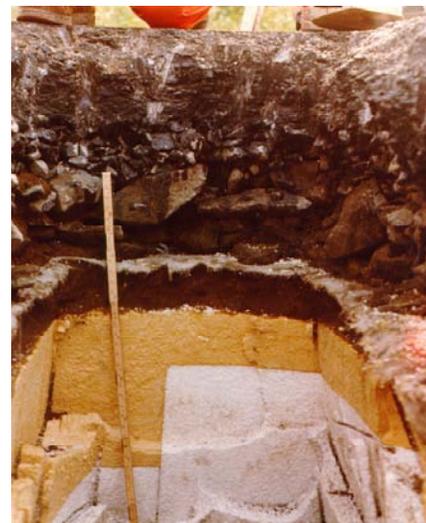
Figure 2. Excavation of the first EPS embankment at Flom bridge

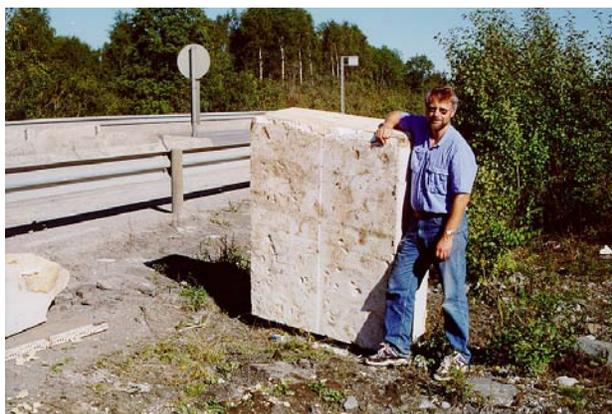
Figure 3. Excavation of a 24 years old EPS block from the first EPS embankment at Flom bridge

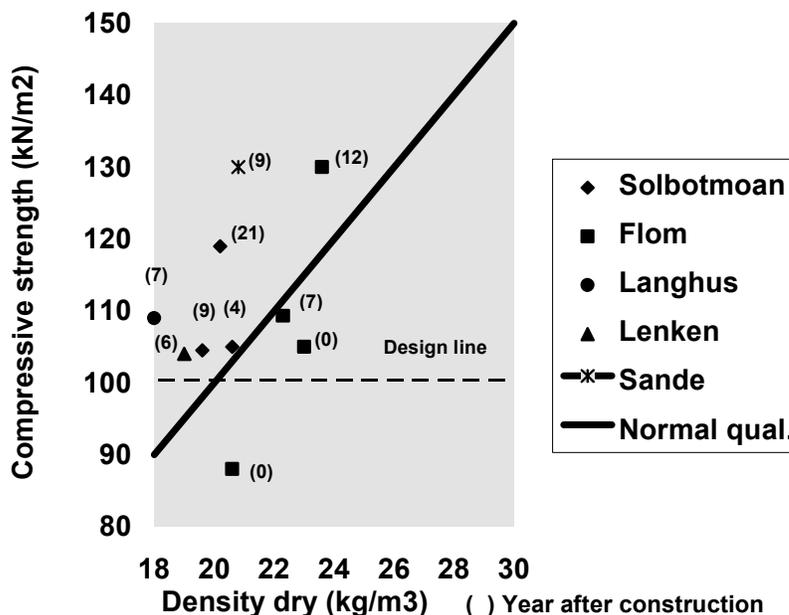
Figure 4. Compressive strength on retrieved samples from EPS fills

One major indicator of possible deterioration of blocks with time would be a decrease in the material strength. The strength tests performed on retrieved samples from fills having been in the ground for up to 24 years are shown in figure 4. as a function of dry unit density and compressive strength. Bearing in mind the criteria mentioned above for accepting blocks to be placed in a fill, all test results give values of compressive strength above $\sigma = 100$ kPa except for one test.

From figure 4 it may also be observed that the majority of tests show values of compressive strength in relation to unit density above that of a normal quality material. Although it is of course impossible to make exact comparisons between material strength at the time of construction and some time afterwards since tests cannot be performed on the same specimen twice, the results indicate clearly that there are no signs of material deterioration over the total time span of 24 years. If a change tendency is to be noted, this would go towards a

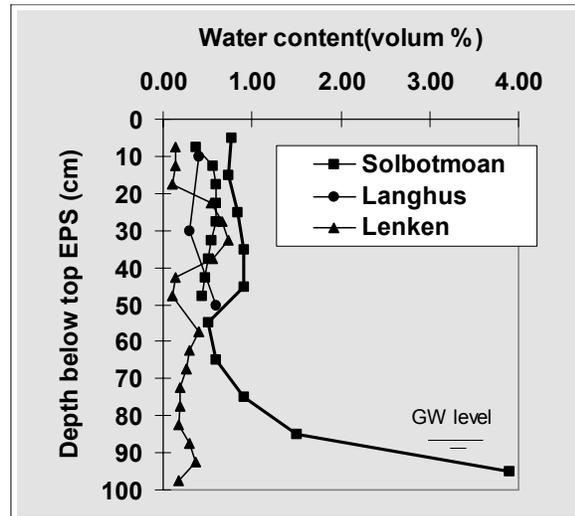
Figure 5. Typical drained situation from 3 EPS fills

Tests performed on samples retrieved from three EPS fills placed in a drained position, i.e. blocks are located above the highest groundwater or flood level, all show water contents below 1 % by volume after more than 20 years in the ground (fig. 5).

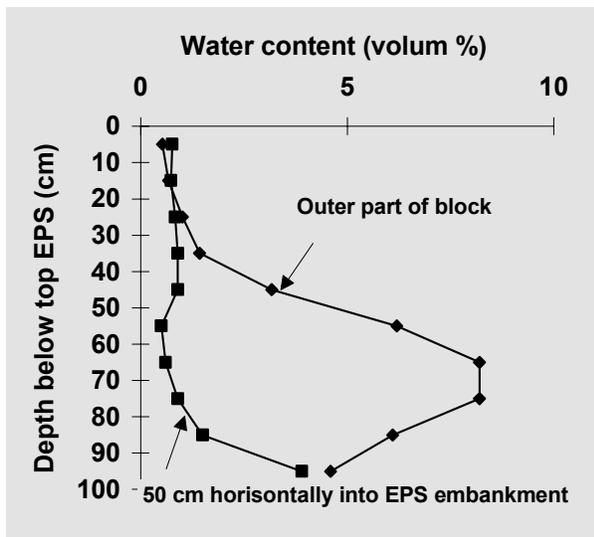
Figure 6. Horizontal gradient of water in EPS.

Furthermore there is hardly any change in the water content with time. Samples retrieved from the outer parts of blocks facing the surrounding soil, may have a higher water content as may be seen from figure 6. But only 500 mm further into the block the water content is again below 1 % by volume. So the average density of drained fills therefore has values of $\rho < 30 \text{ kg/m}^3$. This is well below the specified design value for such fills.

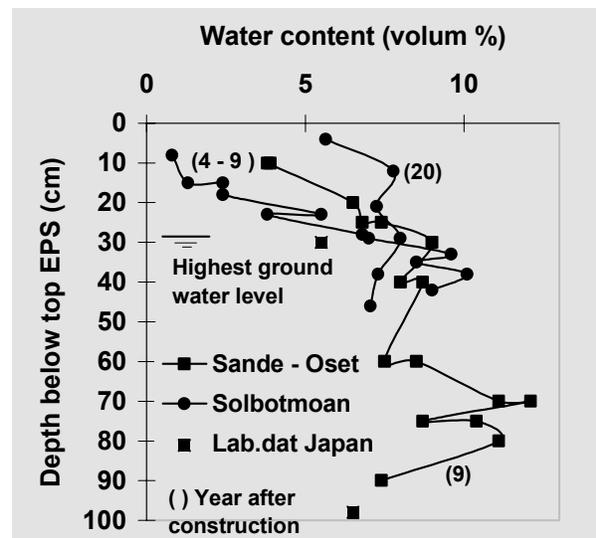
Figure 7. Typical water content in submerged EPS blocks

In blocks, which are periodically submerged, water contents of up to 4 % by volume have been measured. In permanently submerged blocks measured water contents have reached values close to 10 % by volume with some increase over the years fig. 7. Further increases above 10 % by volume are, however, not to be expected. For submerged fills the average density is therefore of the order of $\rho = 90 - 95 \text{ kg/m}^3$ after some 20 years in the ground. The water content decreases rapidly above the water table and show values for drained conditions only some 200 mm above the highest water level.

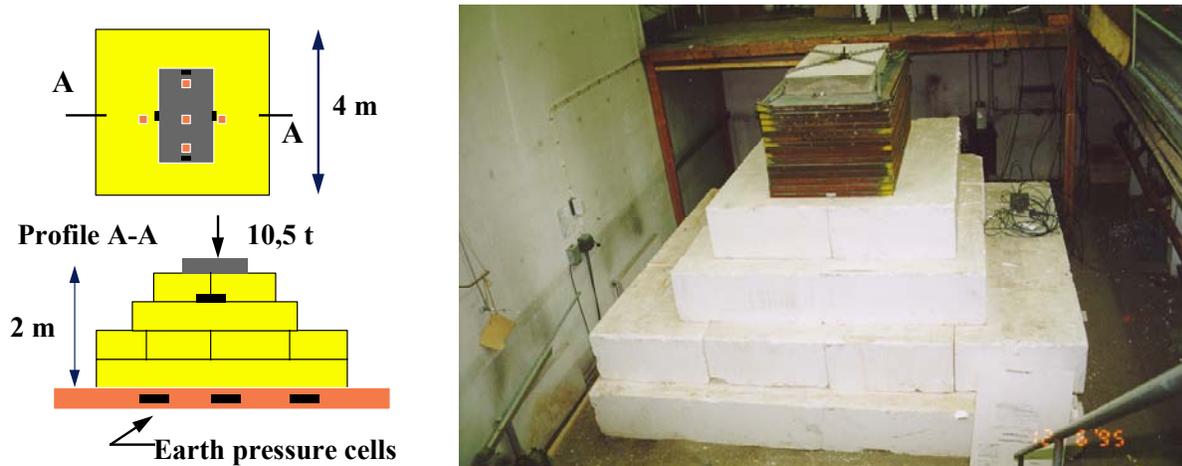
Figure 8. EPS test fill at the Norwegian Road Research Laboratory (now the Road Technology Department).

In a laboratory test at the Norwegian Road Research Laboratory (now the Road Technology Department) a test fill of height 2 m with normal size blocks and a compressive strength $\sigma = 100$ kPa has been loaded to a value of $q_{dw} = 52.5$ kPa and the resulting deformations observed over a period of 3 years (figure 8). The results are shown in fig. 9 together with calculated deformations to be expected according to the theories introduced by Magnan & Serratrice.

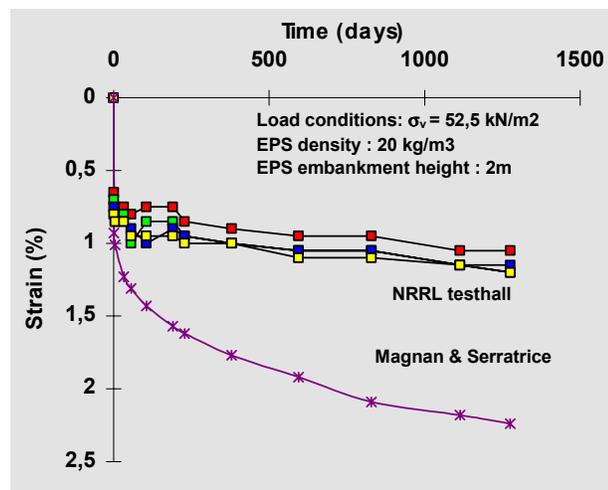
Figure 9. Deformation / creep in the test fill

As may be seen the observed deformations are only about half of the calculated values and creep deformations with time are also much smaller.

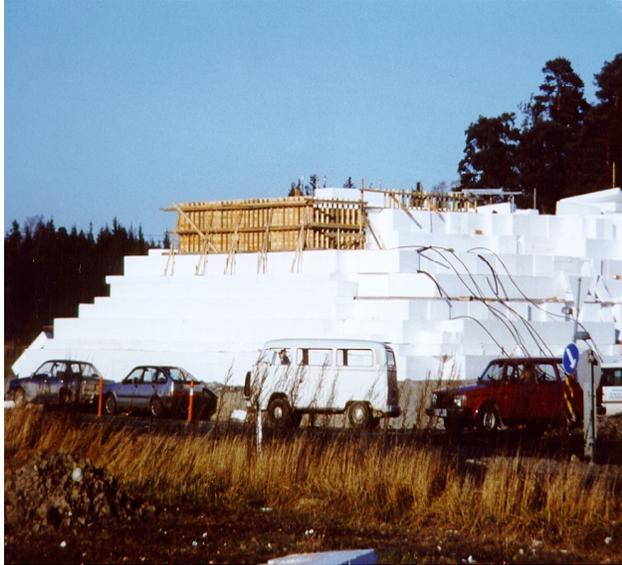
Figure 10. Construction of one abutment on the EPS embankments at Løkkeberg bridge.

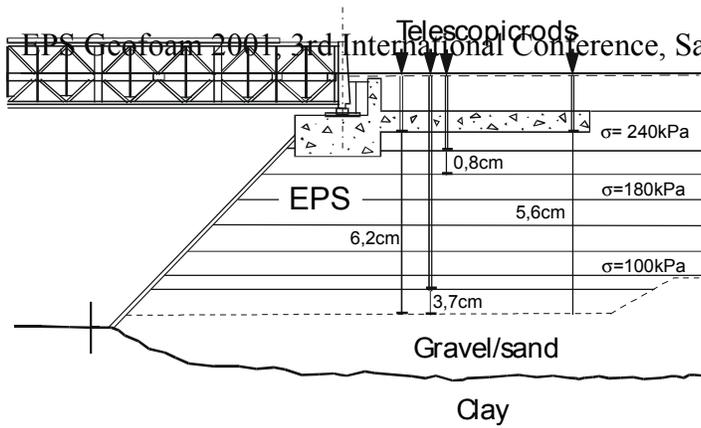
Figure 12. Deformations in EPS embankment at Løkkeberg.

Three different qualities of EPS material strength have been used with design strengths of $\sigma = 240$ kPa in the upper layer directly below the bridge abutment, $\sigma = 180$ kPa in the remaining layers halfway down the fill and $\sigma = 100$ kPa in the bottom half. In the upper layer only 25 % of the material strength has been utilised while in the bottom layer the corresponding figure is 60%. Construction details are shown in longitudinal profiles in figures 11 and 12.

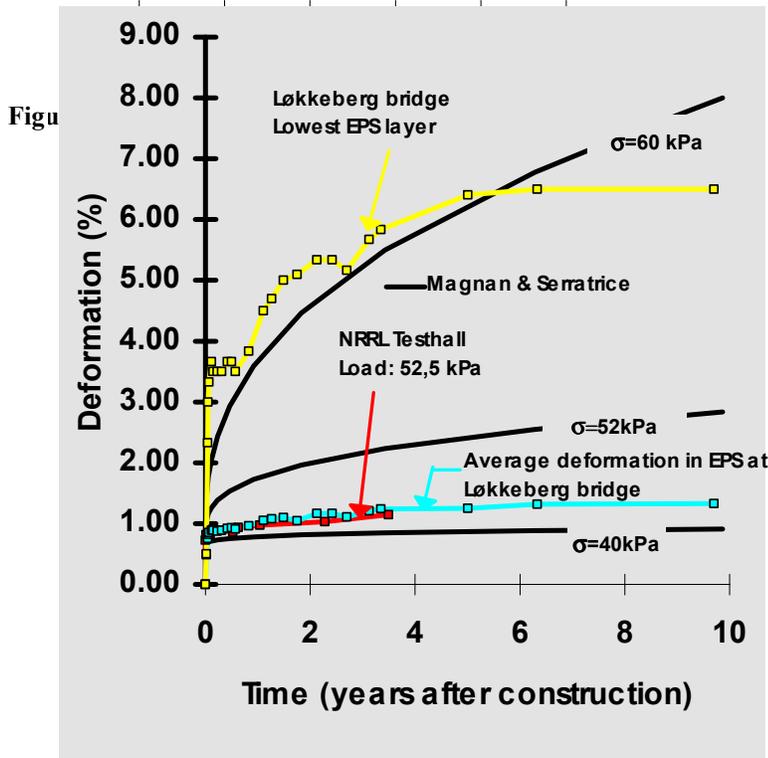
Figure 14. Creep deformations in EPS.

Observed deformations after 10 years in operation are plotted in fig. 14 together with data from the laboratory test and theoretical values according to Magnan & Serratrice calculated for various stress levels

The figure clearly shows that the average deformation at the Løkkeberg bridge is small and slightly over 1 % of the total fill height. Also observed creep effects are almost negligible for the total fill although deformations in the bottom block layer was 4 % initially and later creep effects amount to further 2.5 %. Creep deformations in the bottom layer correspond with the theoretical values the first 5 years but has later slowed down to almost zero.

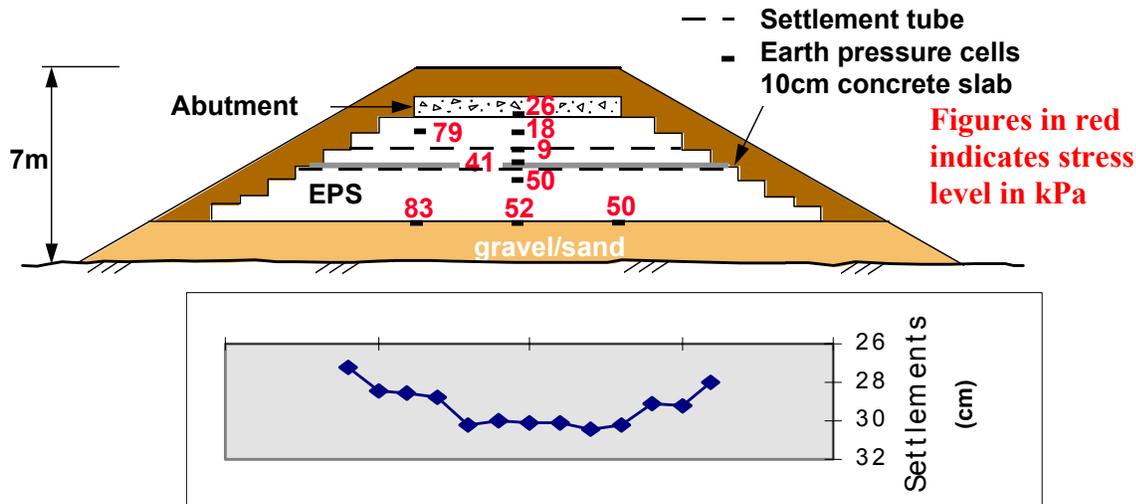
Figure 15. Løkkeberg bridge. Observed stress distribution and settlements in the cross section after 10 years in operation.

In order to observe the stress distribution in the EPS material below the bridge abutment at Løkkeberg bridge during construction and on a long term basis, 10 hydraulic earth pressure cells have been placed in different levels in the fill including 3 cells in the sand layer below the EPS fill. In fig. 15 the measured stress level after 10 years in

service is indicated with red figures.

In the upper part of the fill (with a higher material strength) lower stress than expected has been measured in a zone under the central part of the embankment. One explanation could be some kind of arching effect due to large subsoil settlements in the middle of the embankment. This can clearly be seen in fig.15 where the measurements from the settlement tube are shown. In the lower part of the fill it is difficult to explain load concentration and deformation in

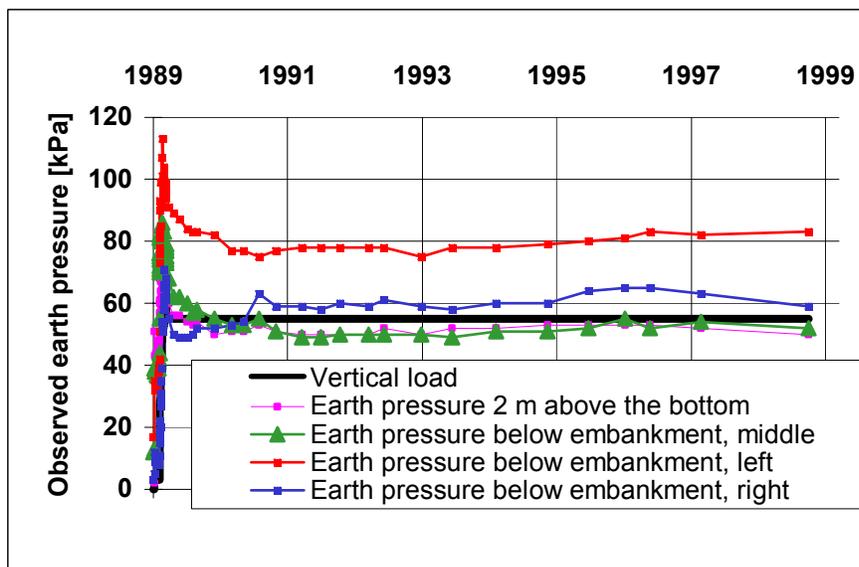
Figure 16. Long term measurements of earth pressure at Løkkeberg bridge

Long term measurements from 3 earth pressure cells below the fill and one situated 2 m higher up have been plotted in fig. 16. During the first year of operation a stress decrease of 15 - 30 % was observed. Later only small variations with time have been observed. Measured stresses corresponds well with the theoretical vertical load in the lower part of the EPS fill.

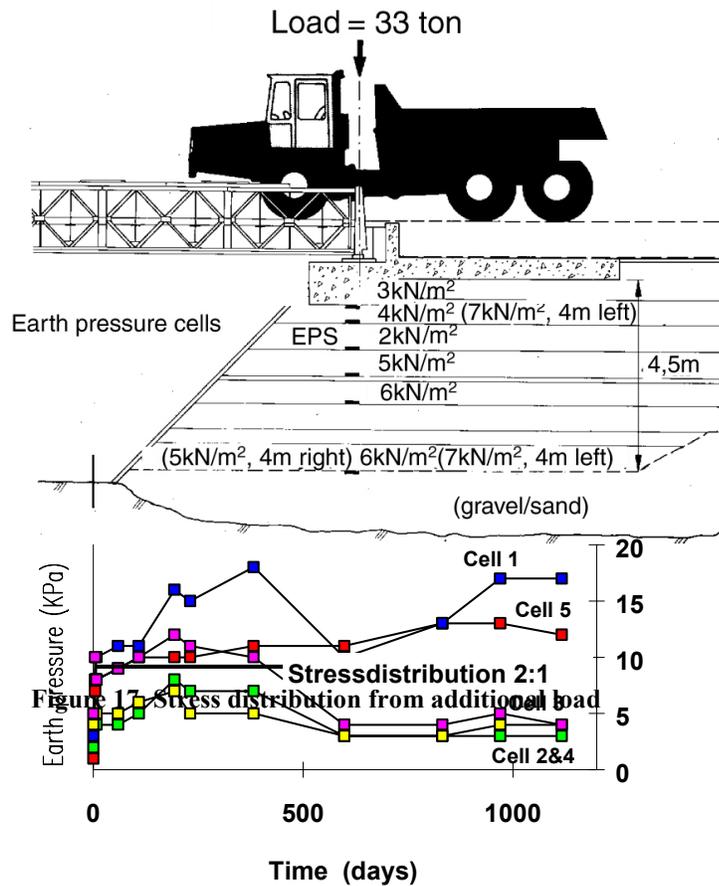
Figure 17. Stress distribution from additional load

expected. The measured stress increases in the various fill levels with the additional load from the dumper correspond well with the stress distribution without the dumper. The increase in stress levels from the dumper is shown in fig.17. The same tendency to reduced vertical pressure in a zone beneath the abutment was also observed here. After unloading the abutment, the pressure cells immediately returned to the initial stress levels.

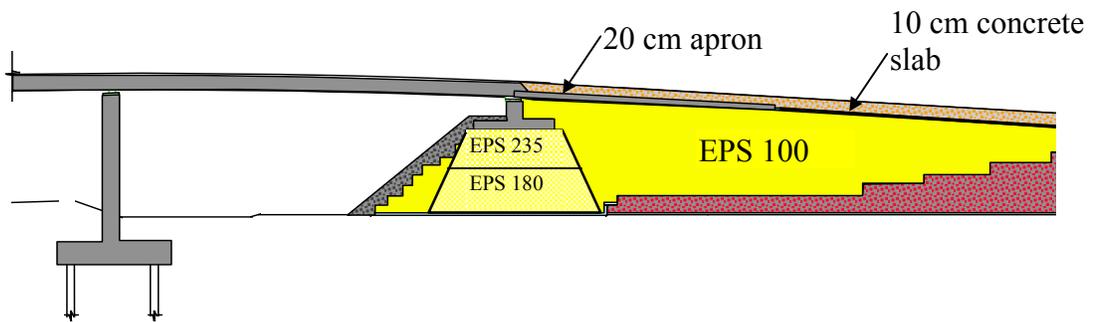
Figure 19. Supporting bridge abutments directly on EPS, Hjelmungen bridge, Norway

the fills with EPS blocks and supporting new bridge abutments directly on the EPS. The repair design is indicated in figure 19.

specified within the indicated zone. For the rest of the EPS fill a material quality of $\sigma = 100$ kPa was used. These quality requirements have been decided based on evaluation of stress distribution in the material in order to keep the stress level for dead loads within 30 % of the material strength. Stricter geometric requirements than normal were also enforced related to block dimensions in order to obtain an even fill and reduce initial deformations when the load from the bridge deck was transferred to the new abutment.

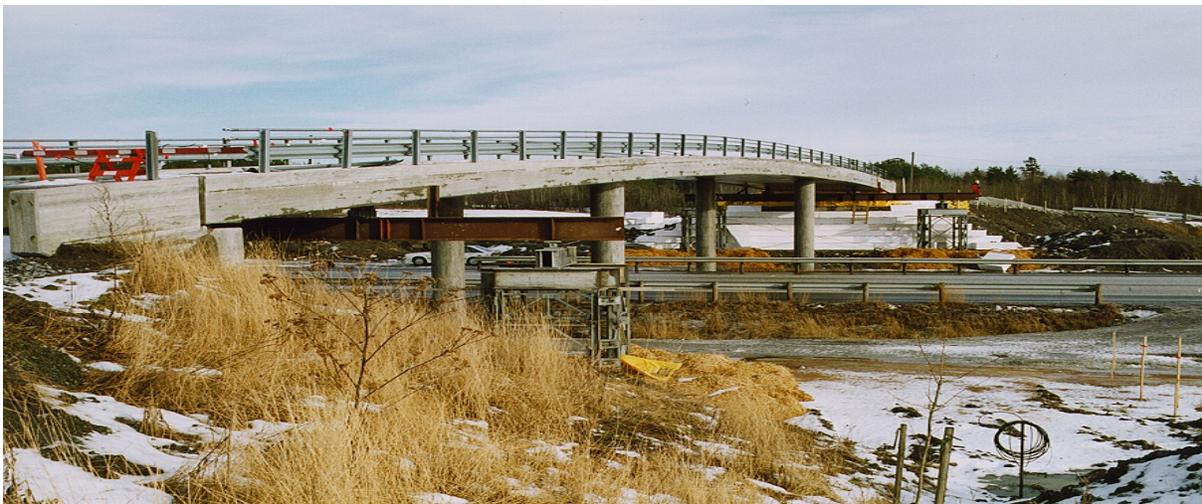
Figure 20. Temporary support of abutments at Hjelmungen

Repair works were initiated in December 1995 and completed in the spring of 1996. One abutment was treated at a time while the bridge deck was provided with a temporary support as shown in figure 20. Thickness and densities of the original filling materials were recorded as they were removed in order to have accurate data for control of load and settlement calculations. After removing the old abutments, the concrete piles were inspected regarding possible damage before being cut at ground level. No pile damage was observed. Construction of the EPS fills could then start. In this case three different qualities of EPS were utilized. In the zone directly beneath the bridge abutment, as indicated by the trapezoidal shaped lines in figure 19, a material quality of $\sigma = 235$ kPa was specified for the first three block layers beneath the bottom slab of the abutment. Further down a material quality of $\sigma = 180$ kPa was

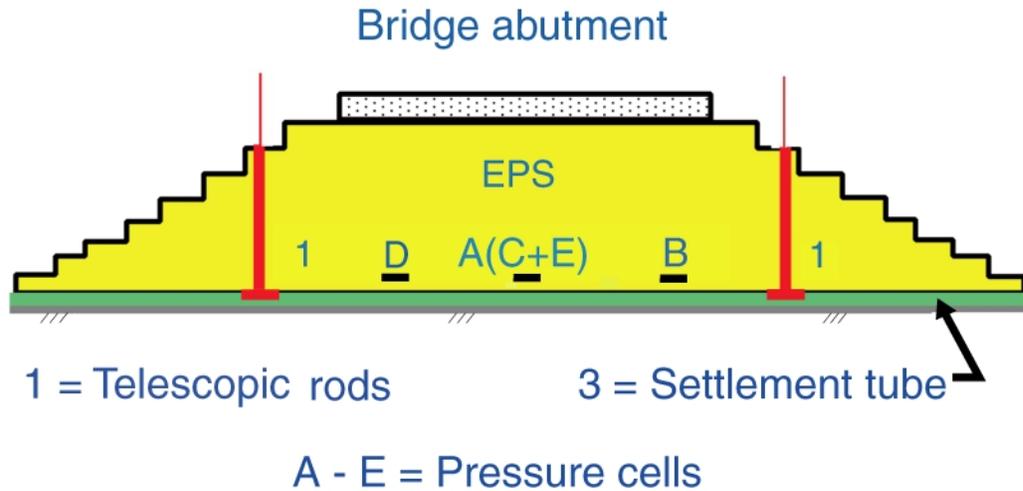
Figure 21. Cross section indicating location of monitoring equipment

In order to monitor the behaviour of the reconstructed bridge both settlement and stress gauges have been installed. The different types of gauges and their locations in relation to the bridge abutment are indicated on the cross section in figure 21. Prior to reconstruction the settlement rates of the adjoining fills were observed to be 100 mm/year and constant. After reconstruction the settlements have nearly been halted as shown on figure 22.

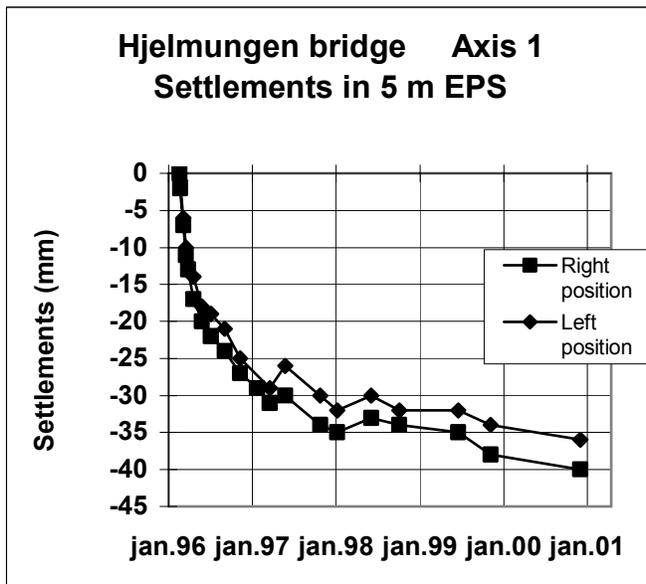
Figure 22. Measured settlements at Hjelmungen

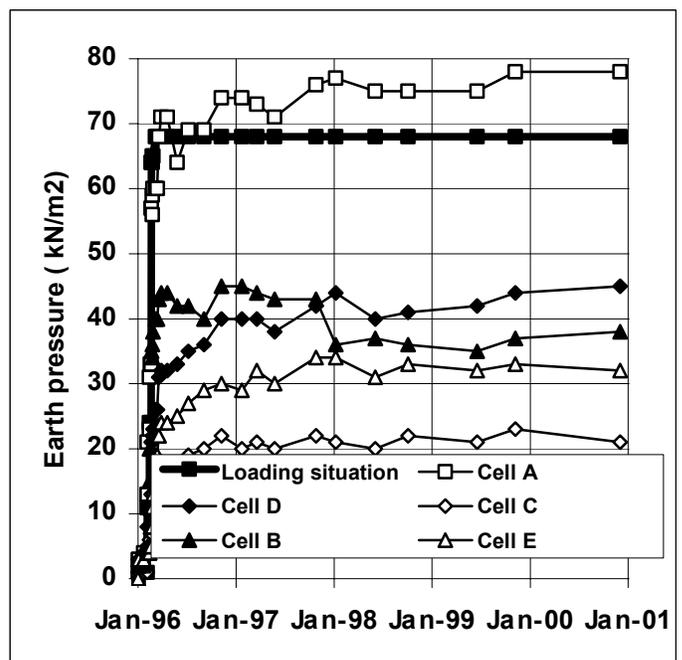
Figure 23. Earth pressure below EPS layer at Hjelmungen

Observed stresses beneath the EPS fill indicate a higher stress under the central part of the abutment than under the edges as shown in figure 23. Calculated loads on the abutment are indicated by the heavy line drawn in the diagram. Problems associated with providing enough lifting force when jacking up the bridge deck may, however, indicate that reaction forces from the bridge deck are somewhat higher than calculated.
